DEPARTMENT OF TRANSPORTATION

Office of Structural Materials

Contract #: 04-0120F4Cty: SF/ALA Rte: 80 PM: 13.2/13.9File #: 69.15**SOURCE INSPECTION REPORT****Resident Engineer:** Siegenthaler, Peter**Address:** 333 Burma Road**City:** Oakland, CA 94607**Report No:** SIR-002670**Date Inspected:** 24-Sep-2010**Project Name:** SAS Superstructure**OSM Arrival Time:** 700**Prime Contractor:** American Bridge/Fluor Enterprises, a JV**OSM Departure Time:** 1900**Contractor:** Zhenhua Port Machinery Company, Ltd (ZPMC), Changxing Island **Location:** Shanghai, China**Quality Control Contact:** Mr. Don Walton**Quality Control Present:** Yes No**Material transfer:** Yes No N/A**Sampled Items:** Yes No N/A**Stock Transfer:** Yes No N/A**OK to Cut:** Yes No N/A**Rebar Test Witness:** Yes No N/A**Delayed/Cancelled:** Yes No N/A**Other:** Coating Inspection**Bridge No:** 34-0006**Component:** See Below**Bid Item:** 77, 78, 79**Lot No:** B #204**Summary of Items Observed:**

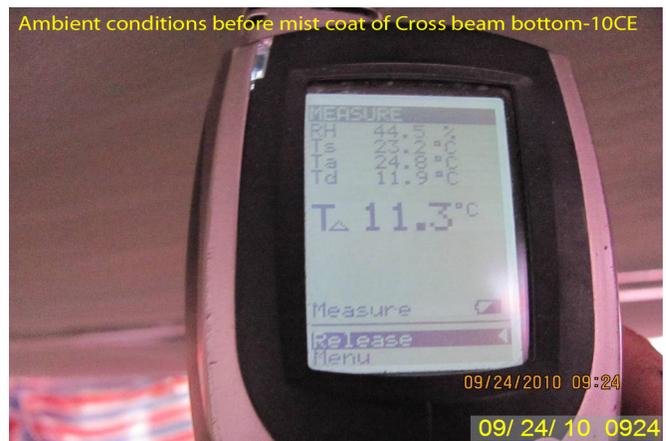
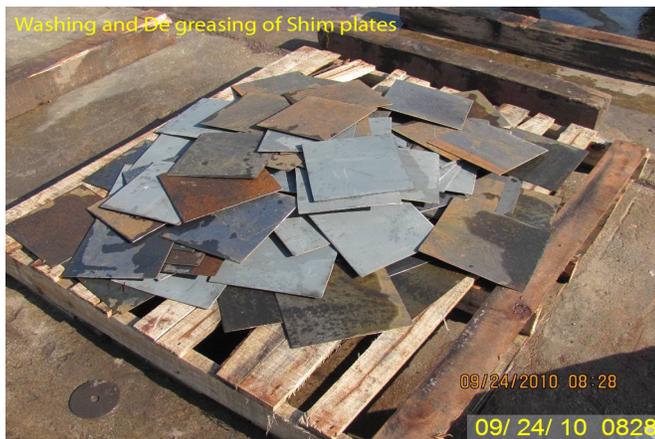
2. An inspection was requested on the OBG Cross beam bottom plate external surfaces, 10 CE, for DFT Check after Interzinc 22 application, Residual chlorides test and MEK test for Mist coat, vide inspection request no. 4415 at OBG trial assembly yard. This QA inspector observed, ABF inspector Mr. Sun, Mr. Wei, Mr. Turtle inspecting all the surfaces. The result of Salt test carried out by ZPMC inspectors at 1 place found to be in the range 20 US/CM and MEK test results conducted at 2 places found to be in the Gr. 5 which is acceptable as per Contract documents. Ambient conditions measured and found to be 11.3 deg. above dew point and the relative humidity found to be 47 % which is acceptable as per contract documents. International protective coatings technical service representative Mr. Li Peng was found present during the course of this inspection process. (Photo of MEK test result and ambient condition measurement with Dew point meter is attached)
